COMPATIBILITIES AND INTERACTIONS

SECTION B9

COMPATIBILITY WITH OTHER MATERIALS

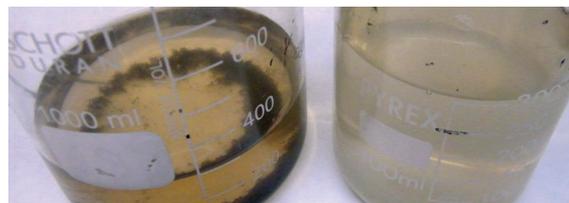
Figure 1 Samples after filtration through a 300-micron sieve – water to the left, brine to the right.

A 0.12 mg/mL CARBO Carbolite 30 / 50 mesh proppant was added to the buffered formate brine and a water sample. The samples were hot rolled at 90°C / 194°F for four hours and then kept in a static oven at 138°C / 280°F for 16 hours. A control sample of buffered brine without any added proppant was given the same treatment.

After thermal ageing, the brine was filtered through 0.45-micron filter paper for cation analysis by ICP-OES to check the gadolinium concentration. The proppant was then washed, dried, and sent to Carbo for ICP composition analysis (Carbo, 2017).

Results show that the formate brine has not undergone any obvious change in critical properties, such as density, pH, or buffer concentrations during thermal ageing, with or without Carbolite proppant. The density of the water sample containing Carbolite increased from 0.999 to 1.0146 g/cm³ / 8.337 to 8.467 lb/gal, which might be caused by some Carbolite powder in the water (see Figure 1). No such density increase was seen in the formate brine. ICP-OES analyses show that gadolinium did not leach out into the brine.

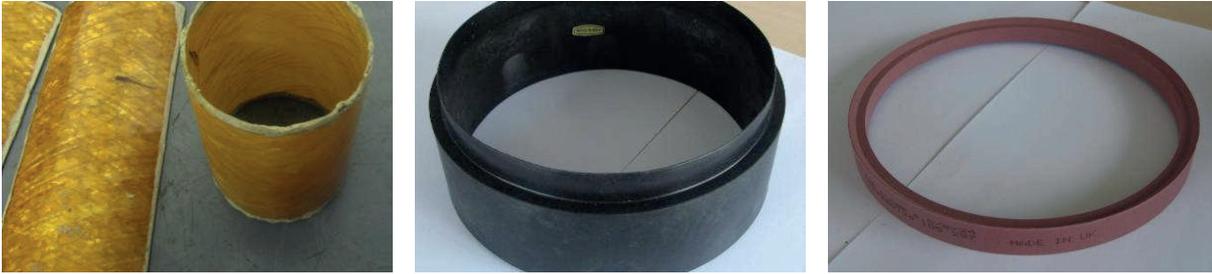
Figure 2 From left: glass-fiber tube, flare ring, and seal ring.

The compatibility of cesium formate brine with three common pipe-liners – thermoset-glass-fiber tube, flare ring, and seal ring – was tested by MERL. These pipe-liner samples were exposed to cesium formate brine for four weeks at 140°C / 284°F (MERL, 2012). Exact details of the materials tested are unknown, but the sample pipe liners are shown in Figure 2.

The thermoset-glass-fiber material lightened uniformly in color during the four-week exposure to cesium formate brine. Mass and volume increased with exposure, but only by 1% overall. The interlaminar shear strength and flexure strength tests both show decreases of about 15%, whilst the Barcol hardness data show a slight increase of three units. See results in Table 2.

The flare ring didn't show any signs of ageing during the four-week exposure to cesium formate brine – there were no changes in mass and volume, appearance, or maximum stress values. However, stiffness increased by up to 42%.

The seal ring showed no significant signs of ageing during the four-week exposure to cesium formate brine. There was no evidence of degradation or change in color, and only very small changes in mass and volume were measured. The flexural properties show a slight increase in maximum stress and stiffness (2% and 20% respectively).
